A Report for
National Association of Broadcasters
Regarding
High-VHF Field Measurements of
ATSC 3.0 Digital Television Signals
in Cleveland, Ohio

October 25, 2016

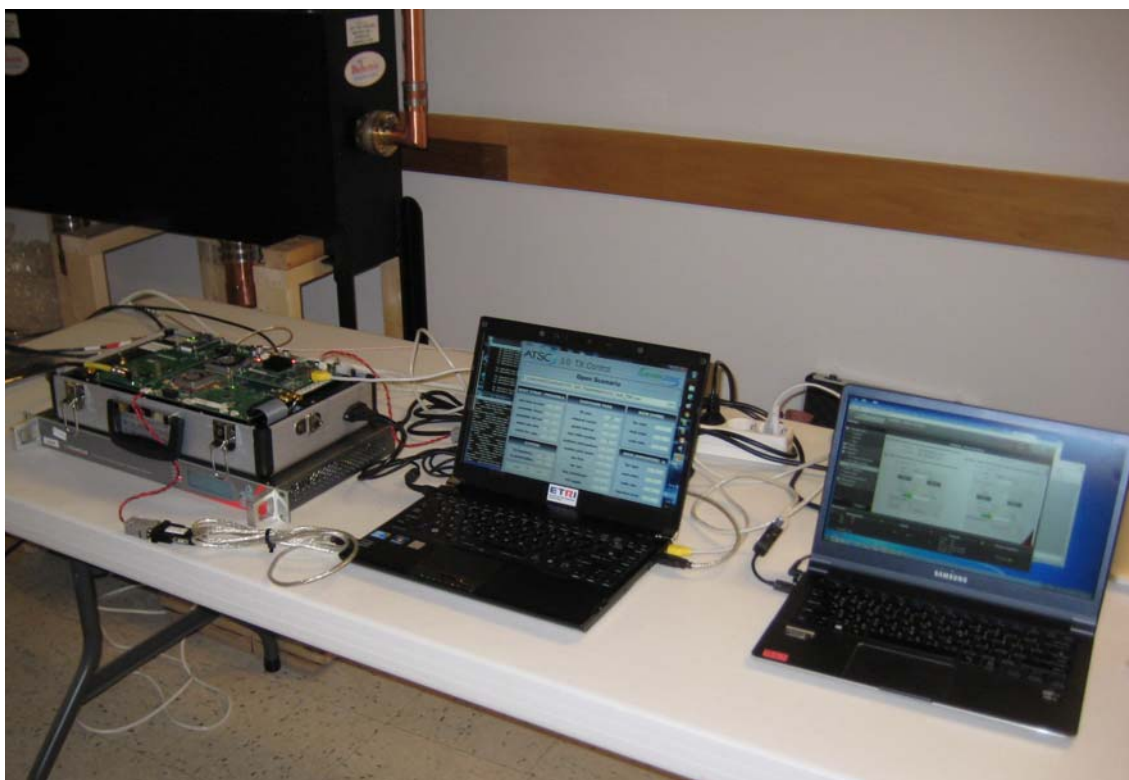
Figure A1-5 ETRI ATSC1 exciter and TeamCast corrector with control computers for each unit.

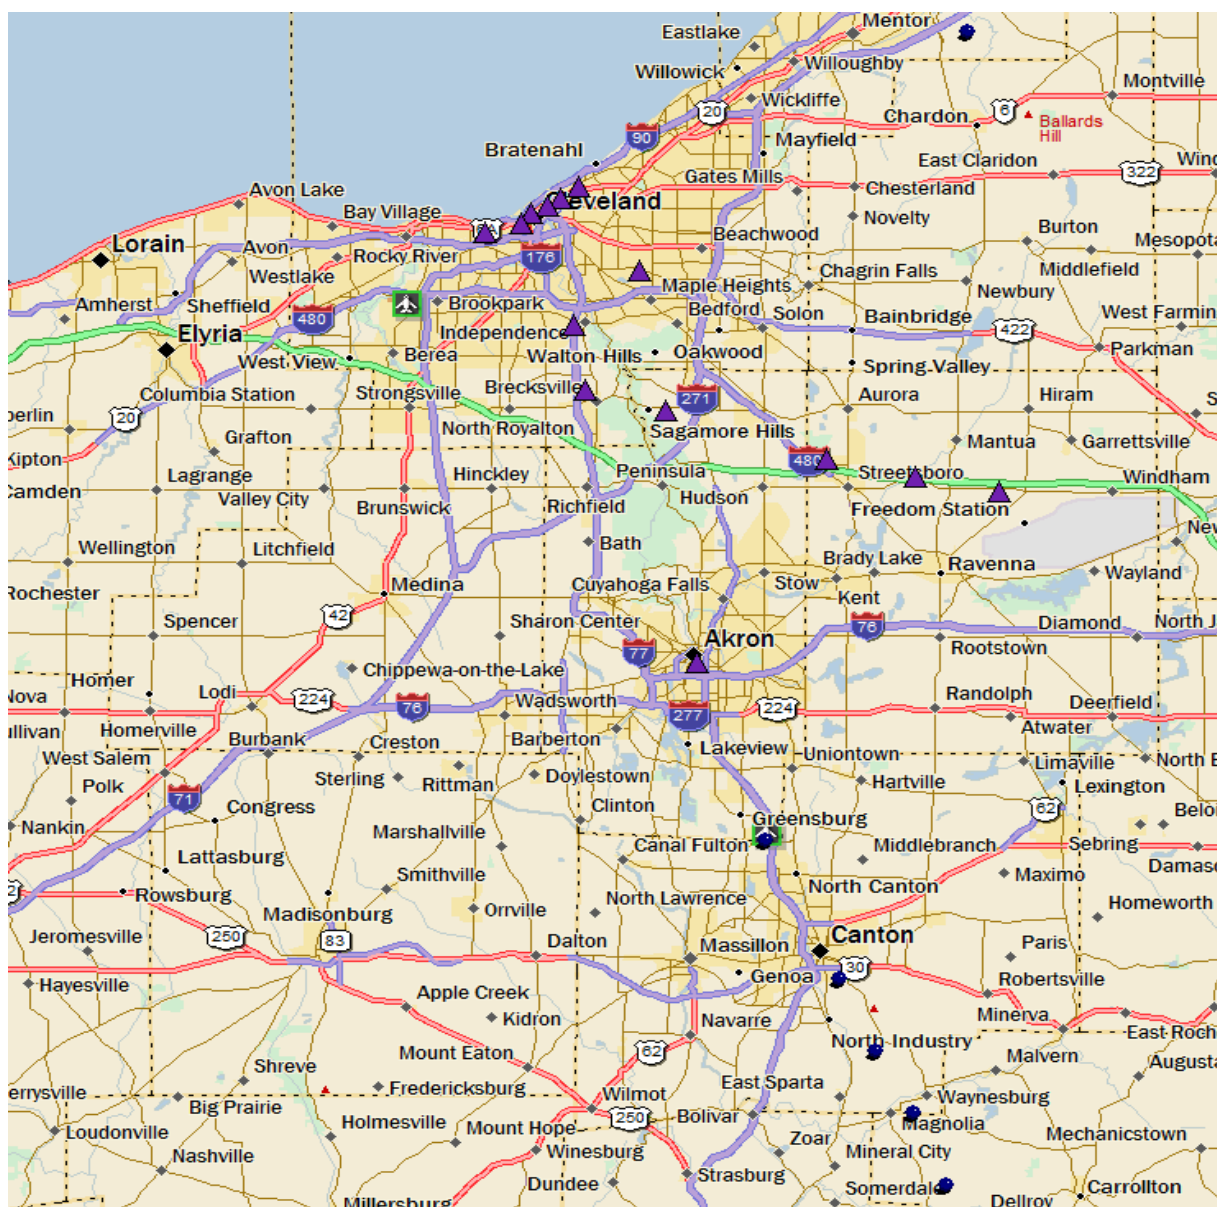
Figure A3-1d Map of Cleveland *outdoor* failed ATSC3 field test sites where ATSC1 had reception. Purple triangles indicate *adjacent channel interference* and blue dots indicated *co-channel interference*.

From these results, the ATSC3 prototype receiver performance is much closer to the mature ATSC1 consumer receiver. Also note that while the ATSC3-A signal was supposed to have an almost identical white noise threshold SNR value as the ATSC1 receiver, it actually was worse (i.e., higher) by 1.2 dB. However, no test sites were found where ATSC1 reception existed, ATSC3 did not, and the signal level fell within this 1.2 dB window. Also, it is clear from the above data that the low-data-rate robust ATSC3 mode was not helped by this analysis since there was no indication that adjacent channel interference caused failed reception.

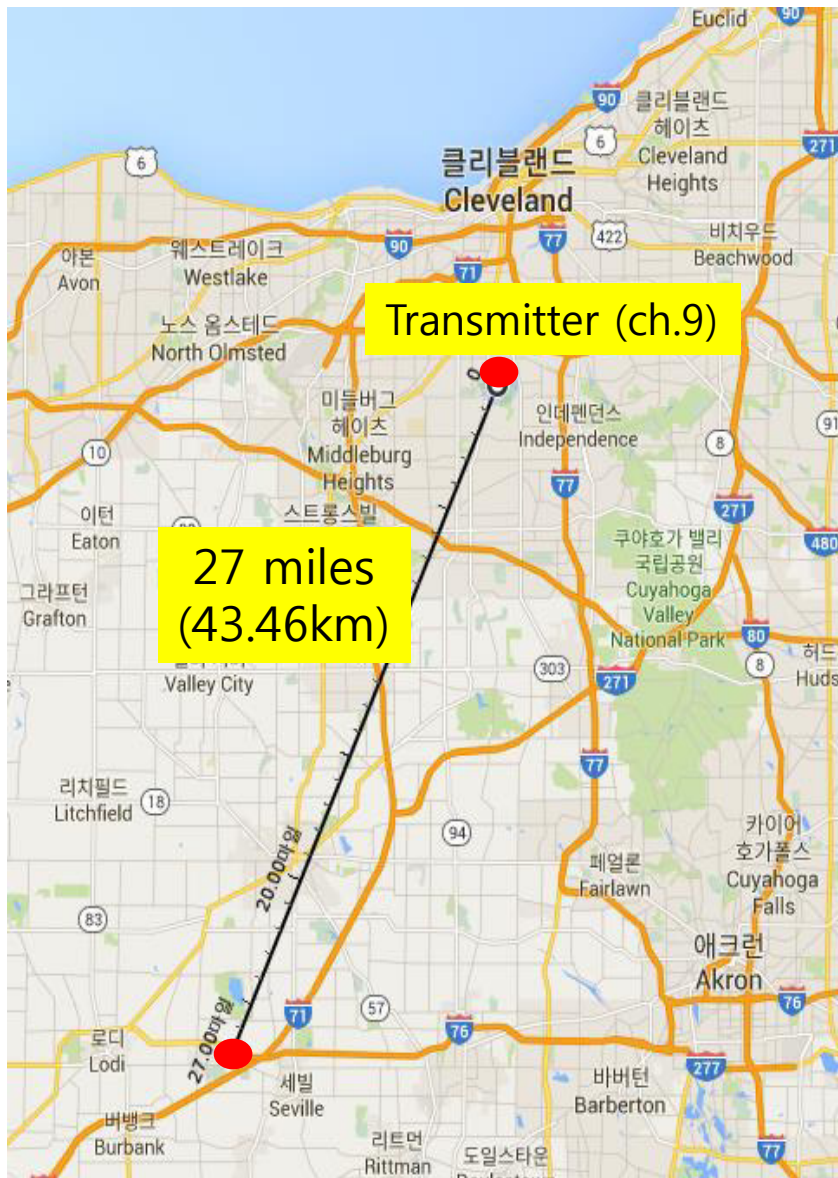
Co-channel Interference (Fixed Measurement)

Transmitter off: -84.2 dBm, Transmitter on: -76.7 dBm
→ CL successful reception (Measured SNR in ETRI Rx = 6dB)
